U.S. DEPARTMENT OF COMMERCE  
National Oceanic and Atmospheric Administration  
National Weather Service - Forecast Office  
2579 South Loop 289 Suite 100  
Lubbock, Texas 79423

FOR IMMEDIATE RELEASE  
Monday, August 11, 2008

The National Weather Service in Lubbock continues to receive a number of inquiries following the damaging thunderstorm that impacted Childress on the evening of Sunday, 15 June 2008. The destructive winds and hail that accompanied the Father's Day storm, which caused six minor injuries and at least \$20 million dollars in damages, resulted from a weather phenomenon known as a wet microburst. Meteorologists at the National Weather Service in Lubbock would like to take this opportunity to present a few facts concerning the event in a public forum.

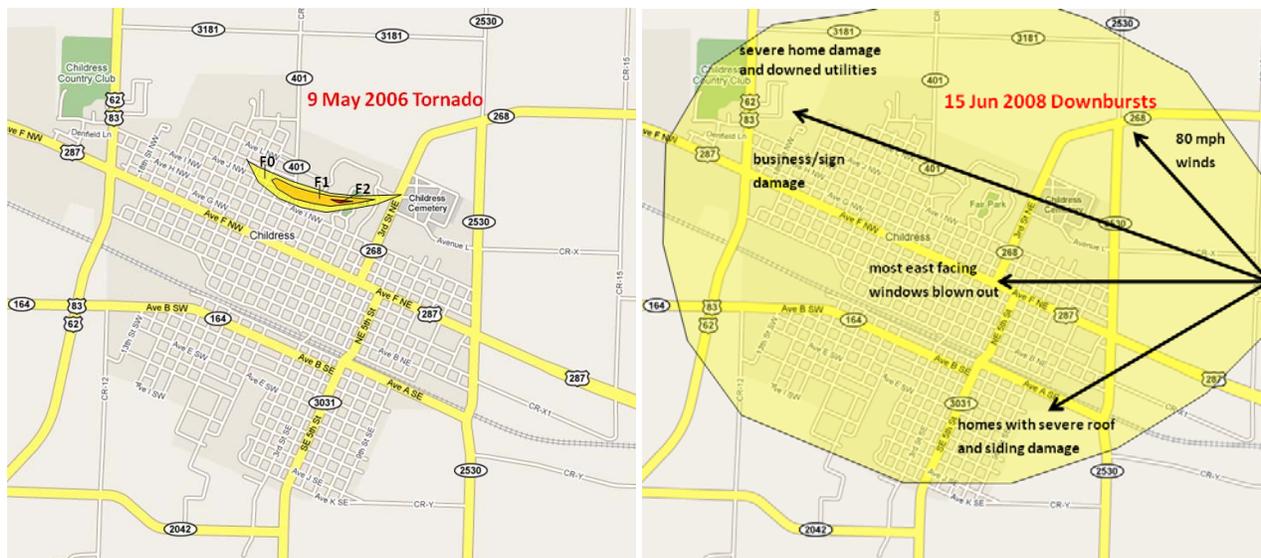
The distinct differences in these damage patterns are best illustrated by comparing the damage path of the 9 May 2006 F-2 tornado which struck portions of Childress to damage from the Father’s Day storm. The tornado in 2006 resulted in a narrow, but significant, 175 yard-wide path of damage along the north side of the city. The 15 June 2008 storm, however, resulted in widespread damage across the city and reportedly impacted 1,821 homes and over 200 businesses. In addition, an estimated \$3 million dollars in crop related damages occurred in the immediate outlying rural areas.

The above maps compare damage patterns that resulted from the 9 May 2006 F-2 Childress tornado (left) to the damage that resulted from the 15 June 2008 downbursts (right). While the tornado left an identifiable “path” through the north side of the city, the Father’s Day storm caused damage over a broad area that diverged from a location east-northeast of the city.

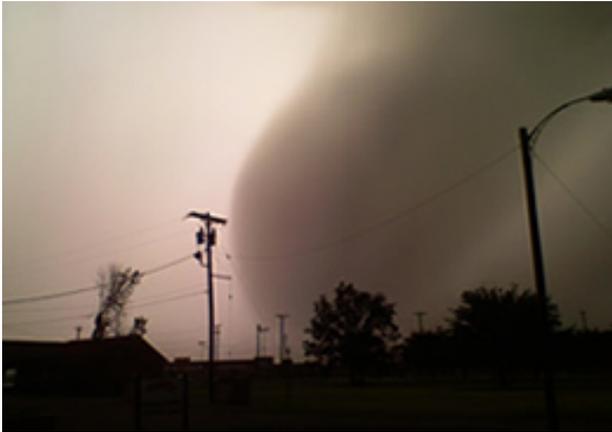
Although much can be determined by detailed post-storm analysis of damage and meteorological data, obviously, photographic evidence of a damaging wind event can be conclusive. Fortunately, the National Weather Service in Lubbock has reviewed numerous photographic images of the Childress 15 June 2008 storm obtained through witnesses and media outlets. All of the photographic evidence presented depicts a classic wet microburst. In some of the images, the descending precipitation core is initially v-shaped. The descending core then appeared to take on a bulbous shape as it approached the ground, and the intense outflow winds turbulently raised wind-blown dust and debris.

*A photograph of a descending wet microburst core taken in Childress on 15 June 2008 (left) is compared to a classic photograph of a similar wet microburst (right) that has been used to train National Weather Service Skywarn storm spotters for more than a decade. The Childress photo above was provided to the National Weather Service in Lubbock by KVII-TV in Amarillo and KAMC-TV in Lubbock.*

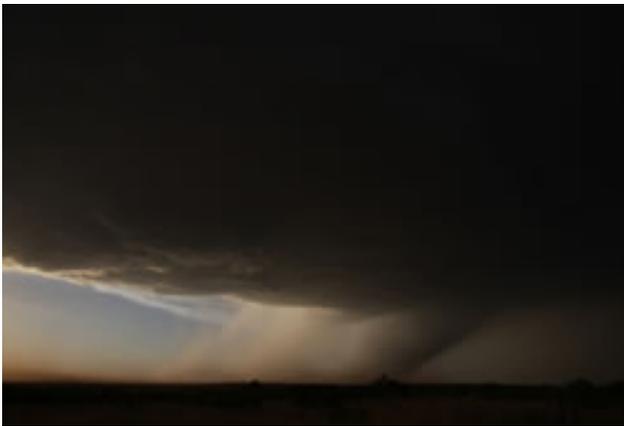
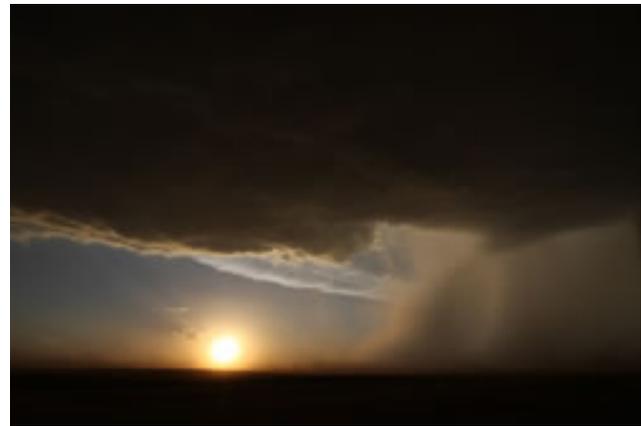
*A series of photographs taken by an observer six miles south of Childress recorded the life-cycle of the 15 June 2008 downbursts. The dense rain and hail core can be seen descending as the opaque v-shaped area in the right-center of the left image. Large amounts of dust reveal areas of damaging winds near the ground in both images, as the downburst subsides in the right photograph.*

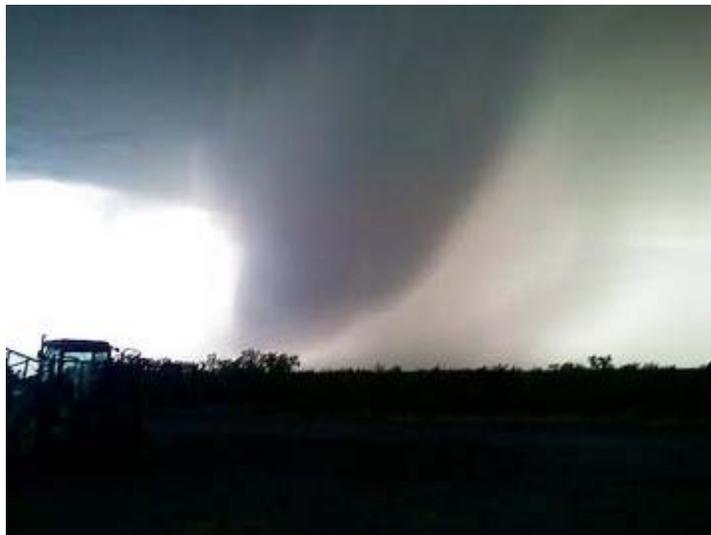
Other photographs, such as the below image, have appeared in various media forums. The photo depicts the early stages of a wet microburst and captures the collapsing precipitation core shortly before it impacted the ground. Although the relatively laminar and v-shaped descending core may appear tornado-like to the untrained eye, several characteristics visible in the photo distinguish this feature from a tornado. For instance, the vertically “streaked” look of the core is consistent with falling precipitation and appears in contrast to the darker and more opaque cloud base – which would be significantly lowered if the feature was tornadic in nature.

This photo depicts the early stages of the 15 June 2008 wet microburst.

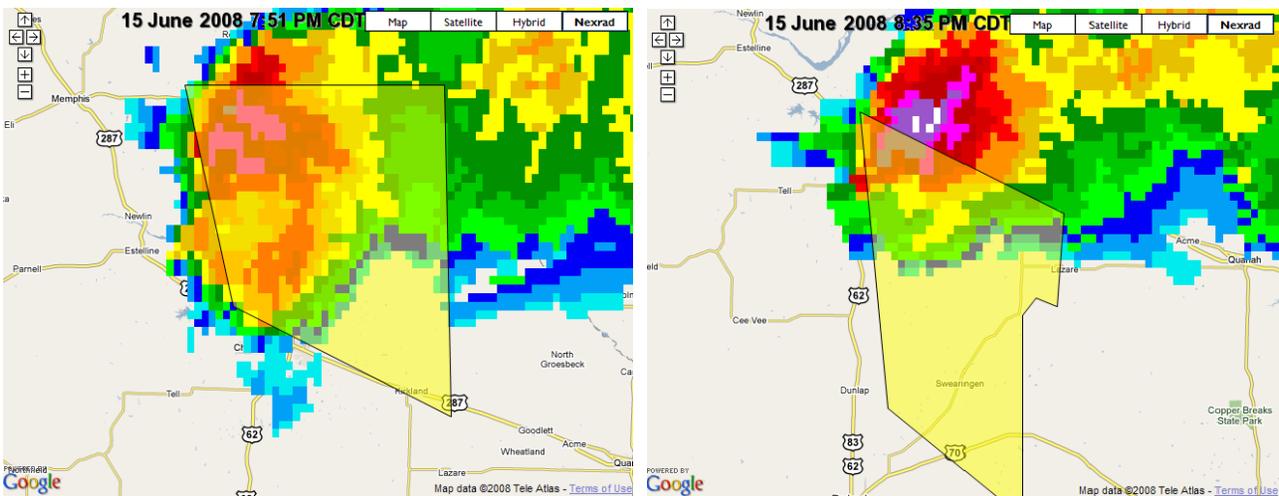
Before the Father's Day storm impacted the Childress vicinity, Doppler radar indicated the potential of a tornado over portions of Donley, Collingsworth, and northwestern Childress Counties. This prompted the issuance of Tornado Warnings from both the National Weather Service offices in Amarillo and Lubbock, which included Childress County by 6:50 pm. Skywarn spotters reported that the storm produced a number of funnel clouds around that time. As the storm persisted and moved southeastward, however, the potential for tornadic activity decreased, and the warnings for Childress County, including the areas near the city of Childress, were extended as a Severe Thunderstorm Warning. This warning, issued thirty-nine minutes before the damaging winds and hail struck the city, stated *"THIS STORM...MAY CAUSE DAMAGE TO PROPERTY OR PERSONAL INJURY"*. A follow-up warning issued at the time that the storm began to impact Childress, at 8:35 pm, additionally stated *"LARGE HAIL BLOWN BY VIOLENT WINDS CAN CAUSE EXTENSIVE DAMAGE"*.

National Weather Service Doppler radar images of the 15 June 2008 Childress storm. The images include the geographic areas covered by Severe Thunderstorm Warnings (yellow shading).
