U.S. DEPARTMENT OF COMMERCE  
National Oceanic and Atmospheric Administration  
National Weather Service - Forecast Office  
2579 South Loop 289 Suite 100  
Lubbock, Texas 79423

FOR IMMEDIATE RELEASE  
Monday, August 11, 2008

The National Weather Service in Lubbock continues to receive a number of inquiries following the damaging thunderstorm that impacted Childress on the evening of Sunday, 15 June 2008. The destructive winds and hail that accompanied the Father's Day storm, which caused six minor injuries and at least \$20 million dollars in damages, resulted from a weather phenomenon known as a wet microburst. Meteorologists at the National Weather Service in Lubbock would like to take this opportunity to present a few facts concerning the event in a public forum.

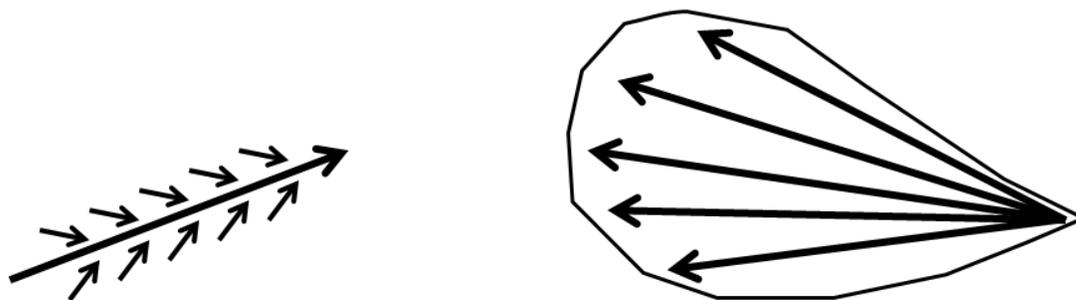
Damage patterns associated with tornadoes (left) are relatively straight, narrow, and converge towards the center of the path. This is contrasted to damage patterns from microbursts (right) which tend to cover a broader area, are more unidirectional, and diverge from a central location.
